Hydrogeological Assessment Report - 245 Church Street, Penetanguishene, ON

November 15, 2022

Prepared for:
Koenig Developments Ltd.

Cambium Reference: 13237-001

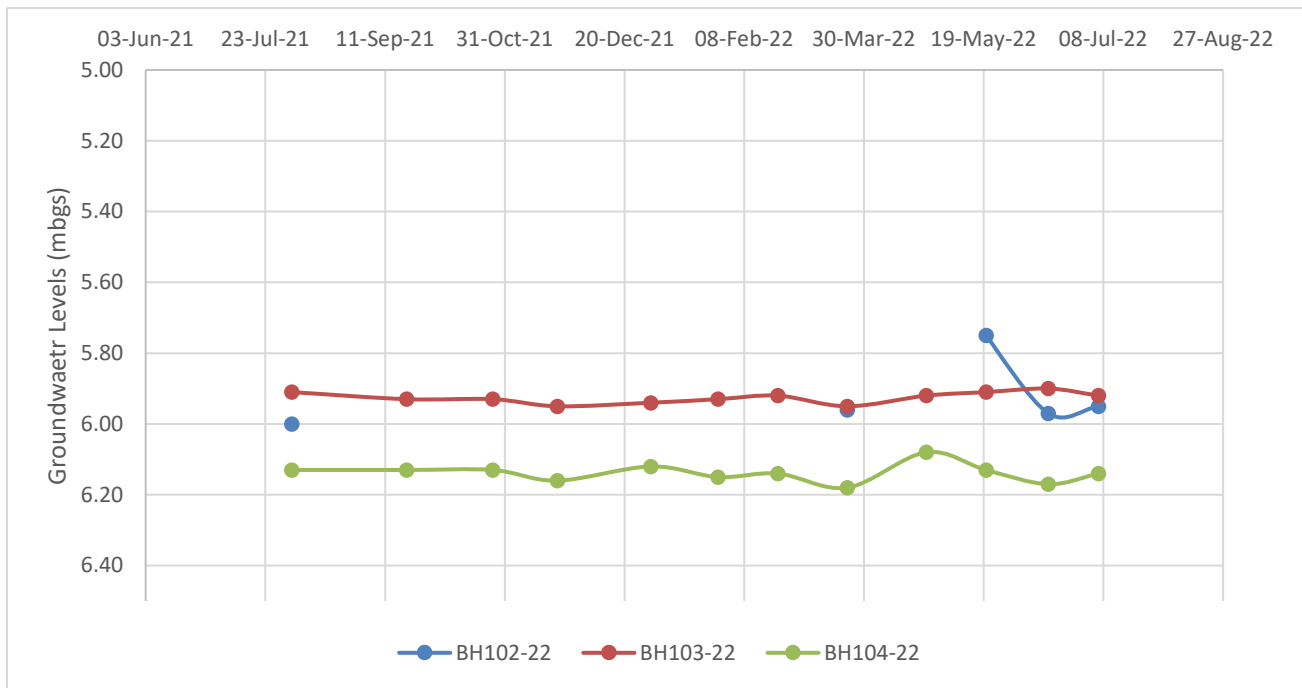
Embedded Figure 1 Depth to Groundwater Levels (mbgs)

As presented above, the spring measured groundwater levels in the monitoring wells ranged in depth from 5.75 mbgs to 6.18 mbgs, and the elevations ranged from 216.47 masl to 218.92 masl. As per the long-term water level monitoring, BH102-21, has witnessed water levels only in the spring and was dry rest of the year. The seasonal high-water level of 5.75 mbgs was recorded in the month of May 2022 with the corresponding highest water table elevation at 218.92 masl.

Based on the groundwater monitoring data , the spring measured groundwater levels in the monitoring wells ranged in depth from 5.75 mbgs to 6.18 mbgs, and the elevations ranged from 216.47 masl to 218.92 masl. Since, the depth to water level is more than 2 m below the bottom elevations of the likely basements, no dewatering either short or long term would be required for the proposed development under the existing ground conditions.

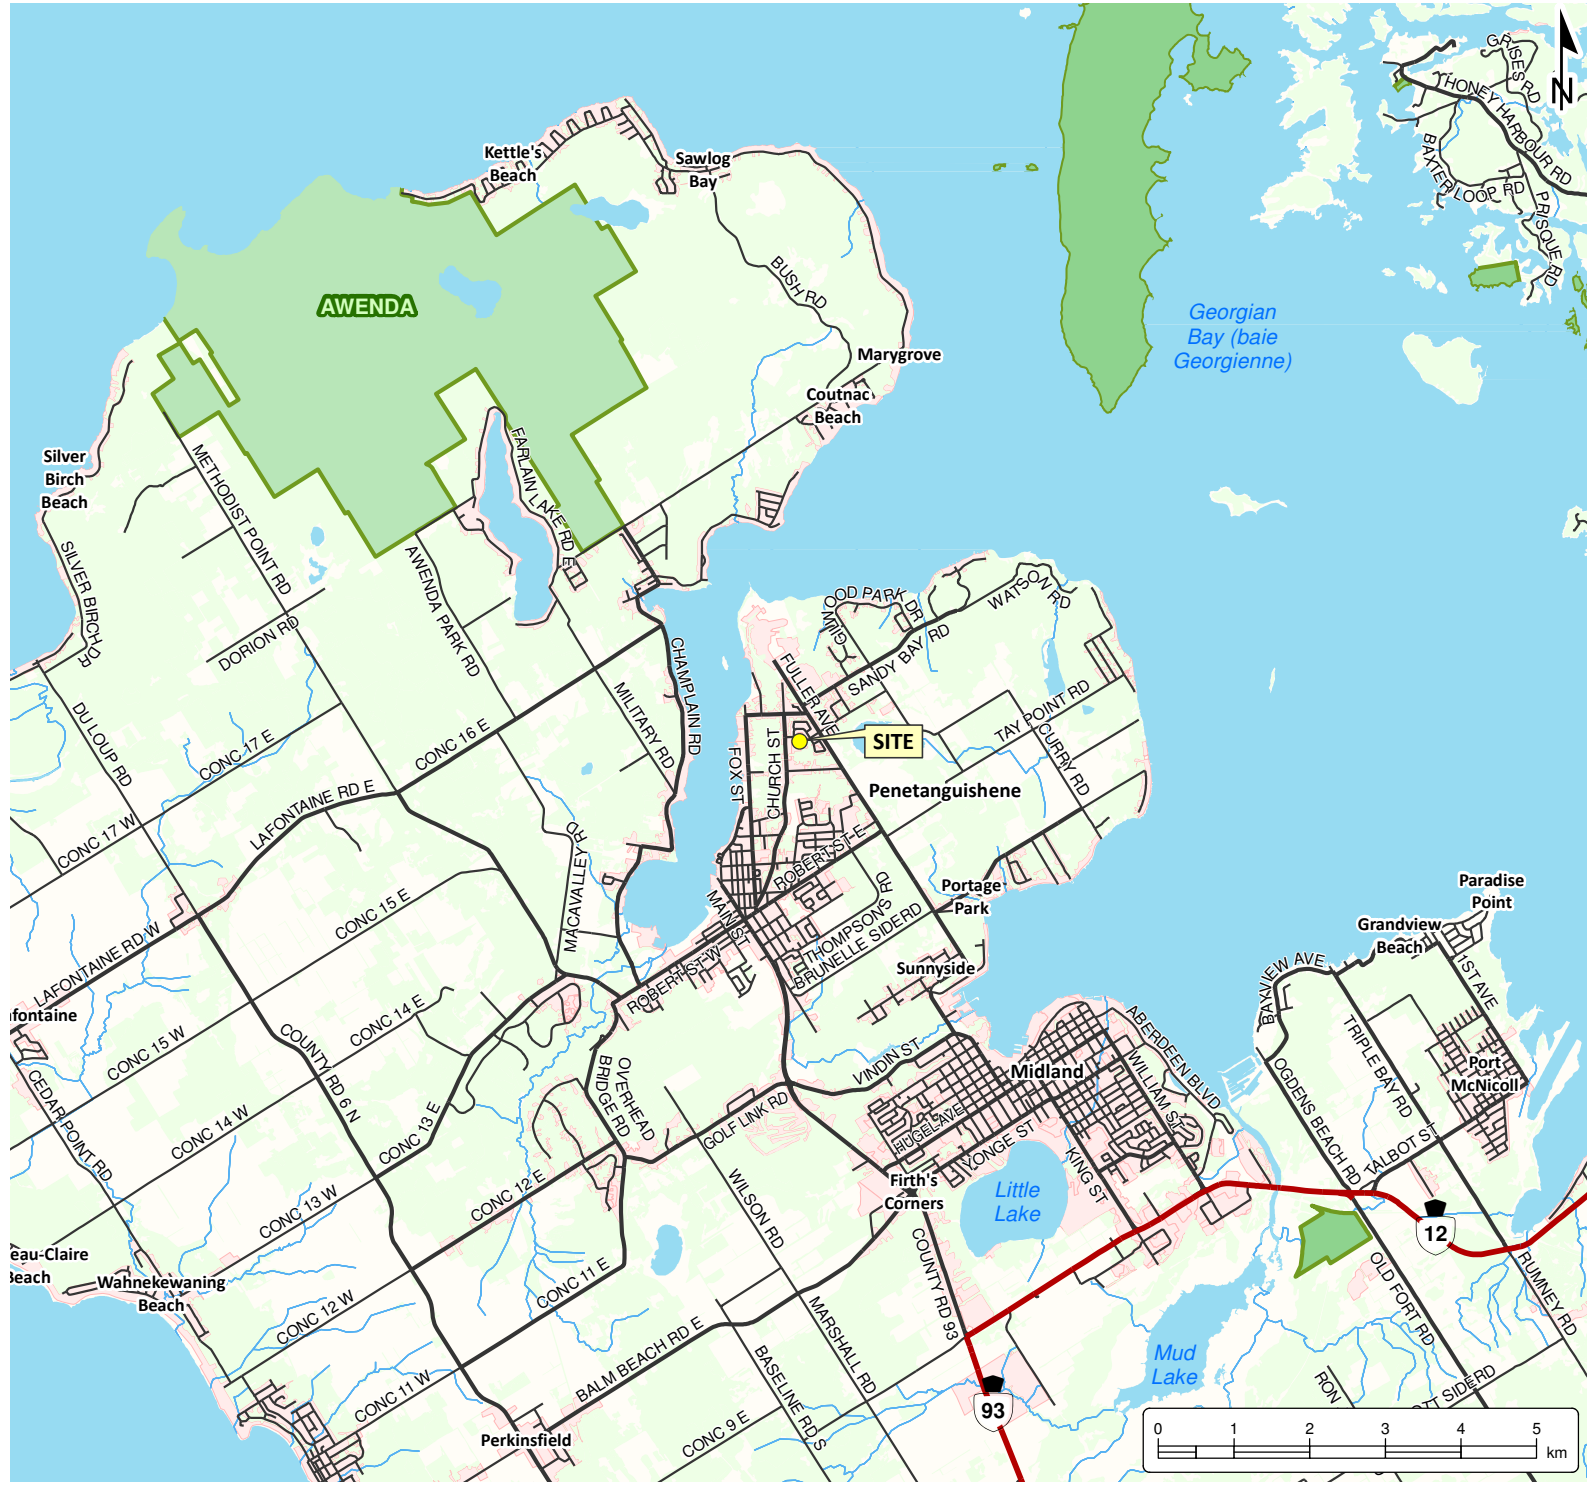
REGIONAL LOCATION PLAN

The regional location of the Site is outlined on Figure 1, the property and surrounding areas outlined on Figure 2, and the proposed development plan is included in Appendix A.

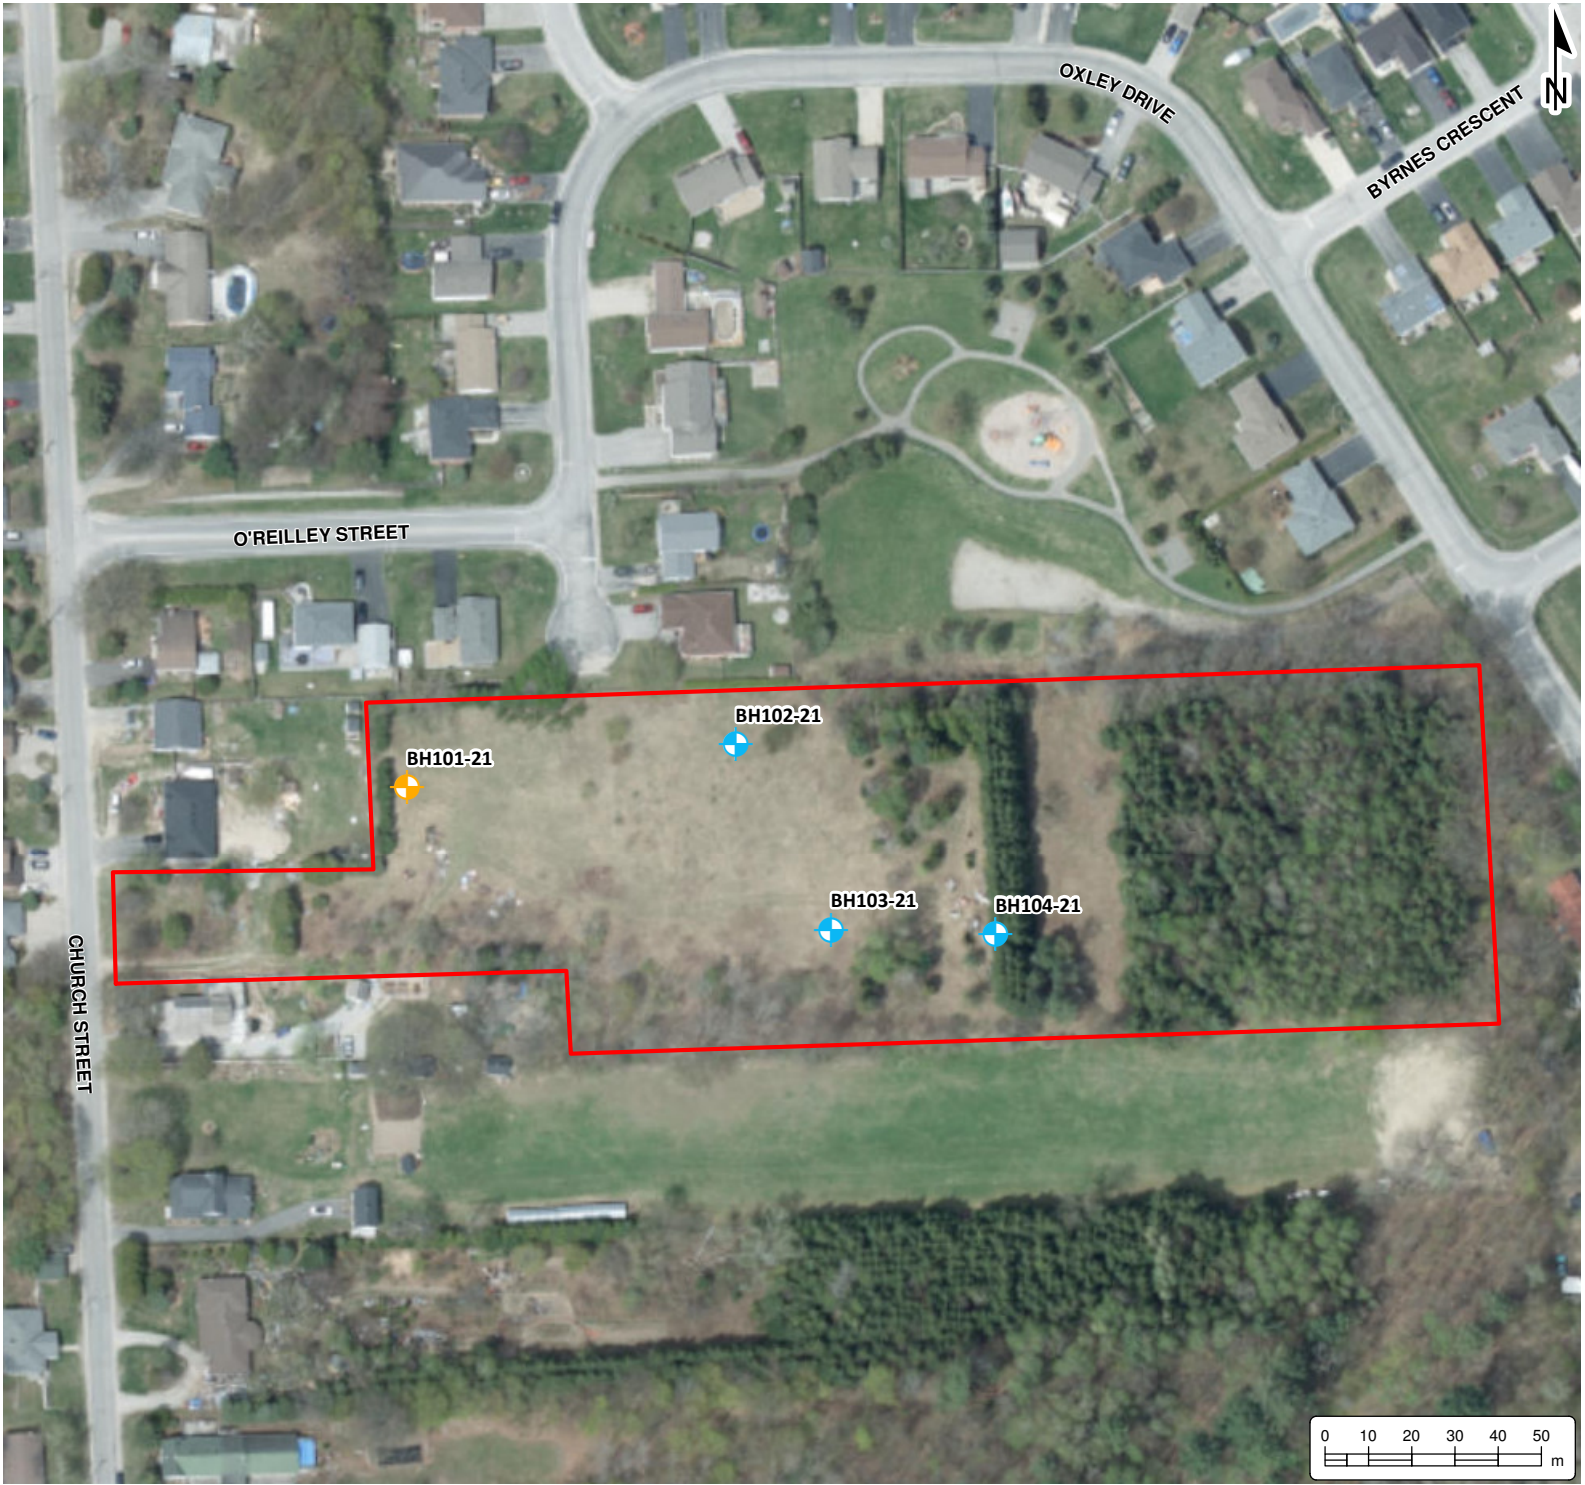
O:\GIS\MD\13200-13299\13237-001 Schuren Snelandaregion - Water Balance and Hydrogeological Assessment - 245 Church St\2022-02-01 FIG 4 - Borehole Location Plan.mxd

Cambium completed a geotechnical investigation at the Site on July 21, 2021, to assess the subsurface conditions. A total of four boreholes, designated as BH101-21 through BH104-21, were advanced to a depth of 6.6 m below ground surface (mbgs). Borehole locations are appended as Figure 4. Borehole logs are included in Appendix C.

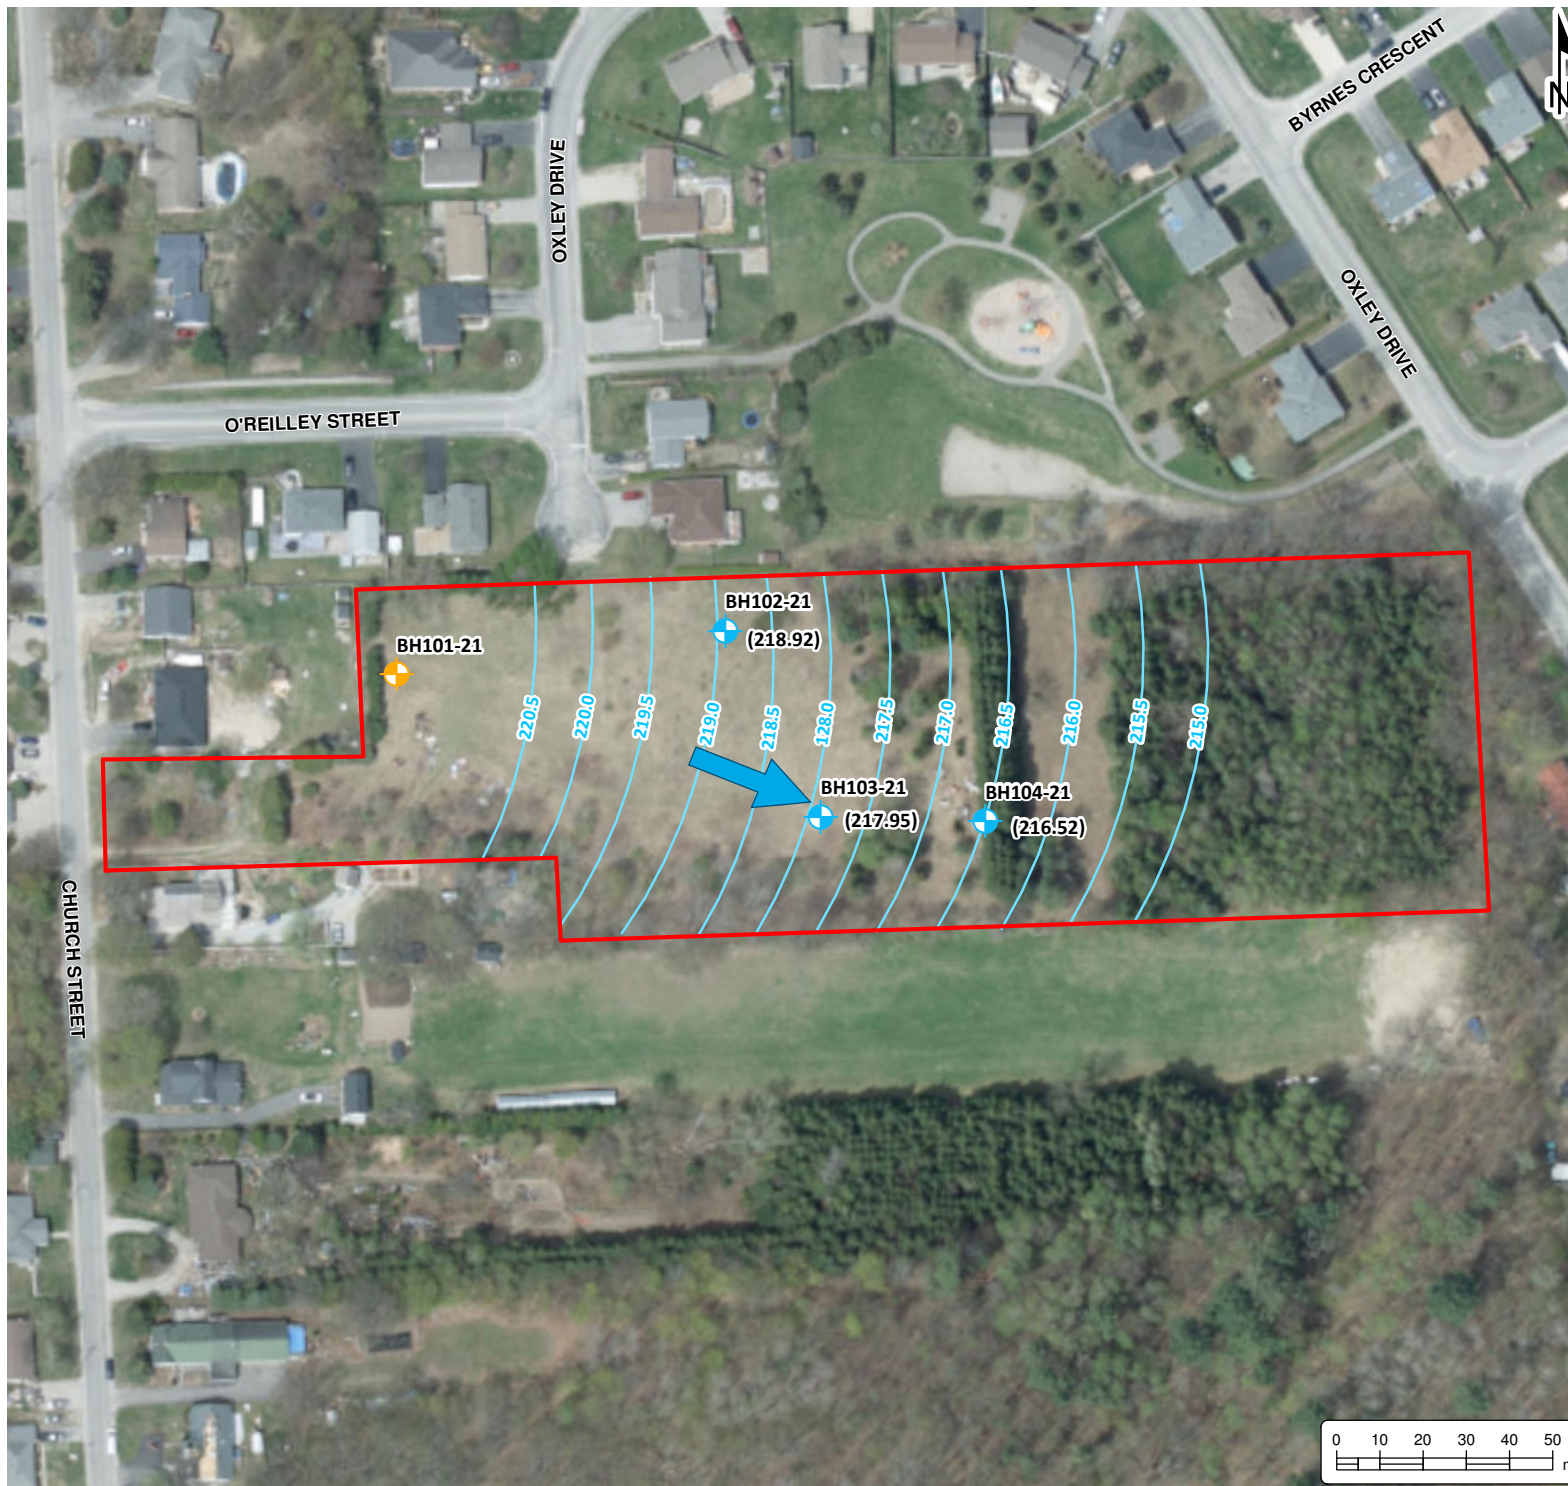
O:\GIS\MXD\13200-13299\13237-001 Schuren Sieslandarajah - Water Balance and Hydrogeological Assessment - 245 Church St\2022-02-01 FIG 5 - Groundwater Configuration Map.mxd

Based on the groundwater elevation data obtained from the monitoring event (May 20, 2022), a site-specific groundwater elevation contour map was prepared to present the groundwater flow direction across the Site. As shown in Figure 5, the groundwater flow direction was found to be east and southeast following the local surficial drainage.

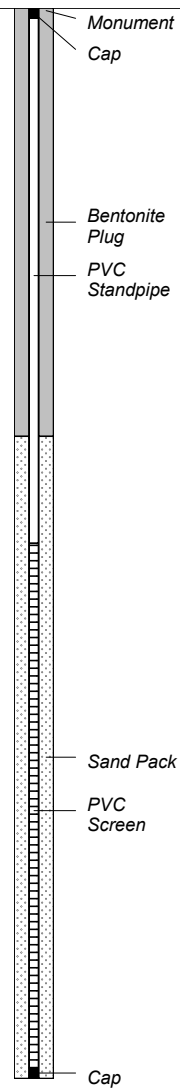
SUBSURFACE PROFILE				SAMPLE												
Elevation (m)	Depth	Lithology	Description	Number	Type	% Recovery	SPT (N) / DCPT	% Moisture			SPT (N) / DCPT	Well Installation	Remarks			
								25	50	75	10	20	30	40		
0			TOPSOIL: Black sand, some silt, with organics, loose, moist [TOPSOIL]	1A	SS	90	6									
224			SAND: Brown sand, some silt, trace clay, trace gravel, loose, moist	1B	SS	90	6									
	1		-less silt content	2	SS	80	7									
223				3	SS	70	6									
	2															
222				4	SS	70	9									
	3		-compact													
221				5	SS	70	21									
	4															
220			SILTY SAND: Grey silty sand, some gravel, trace clay, very dense, moist	6	SS	70	50									
	5															
219																
	6															
218			Borehole terminated at 6.6 mbgs due to target depth achieved.	7	SS	0	50/100 mm									
	7

Top of Pipe (TOP) elevation: 225.46 mASL. Groundwater measured at 5.95 mbgs (218.72 m Rel. El.) on July 6, 2022

GSA SS2:
 1% Gravel
 80% Sand
 15% Silt
 4% Clay

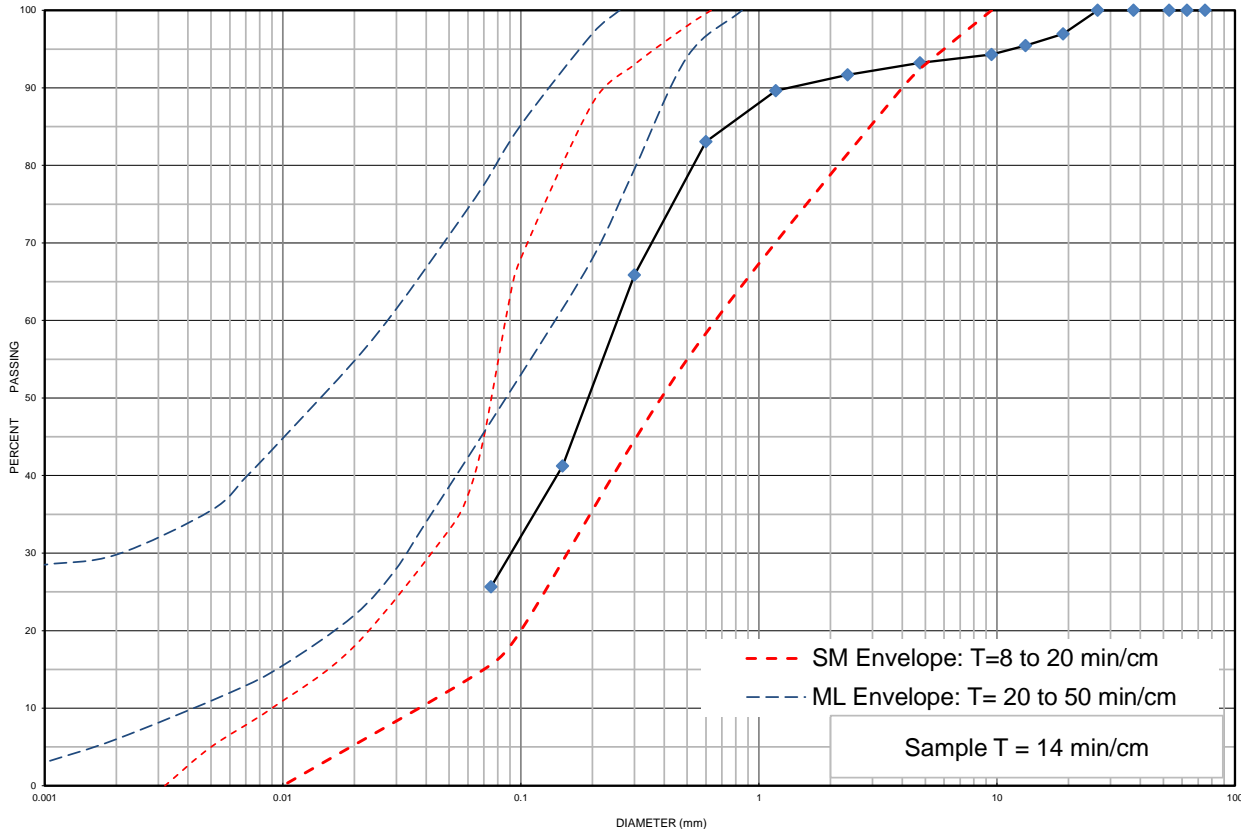
Borehole No.	Sample No.	Depth	Gravel	Sand	Silt	Clay	Moisture
BH 101-21	SS 3	1.5 m to 2 m	7	68	25		9.5
Description		Classification	D ₆₀	D ₃₀	D ₁₀	C _u	C _c
Silty Sand trace Gravel		SM	0.255	0.090	-	-	-

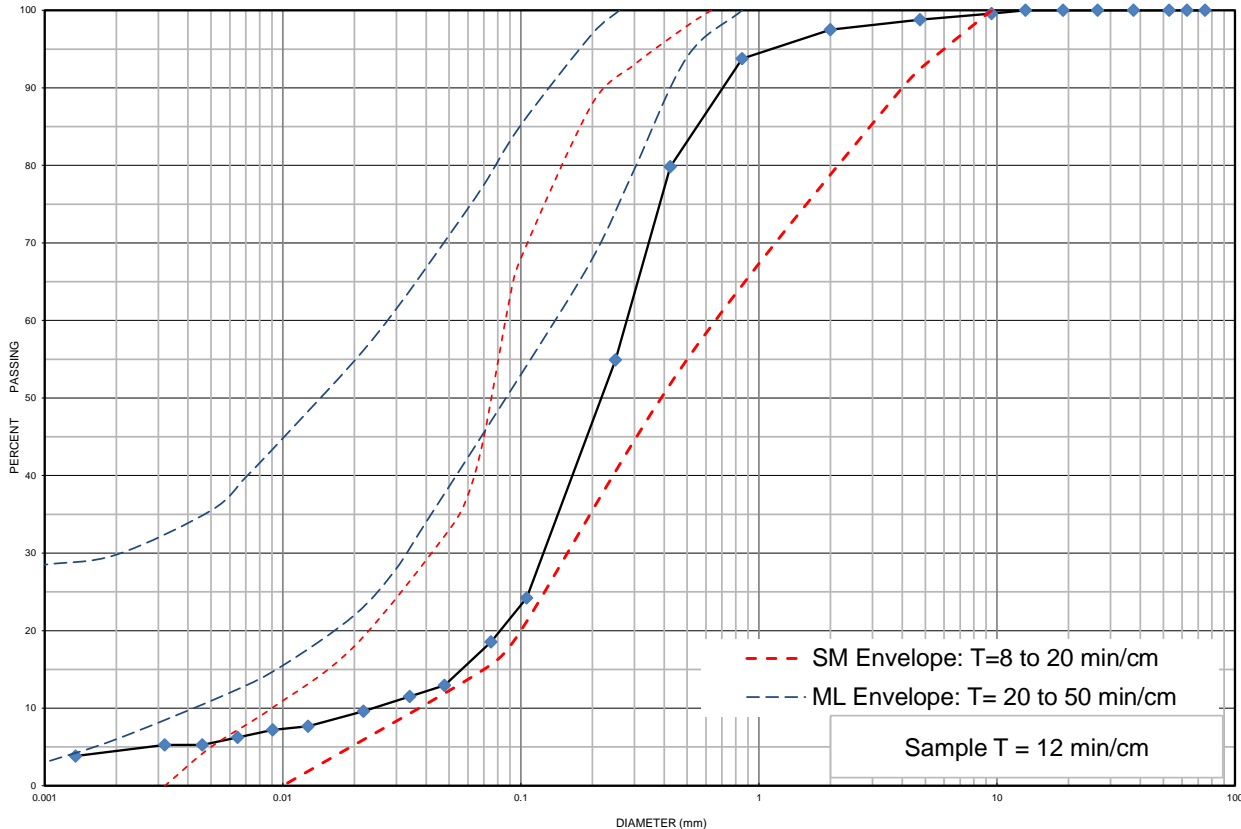
Borehole No.	Sample No.	Depth	Gravel	Sand	Silt	Clay	Moisture
BH 102-21	SS 2	0.6 m to 1.2 m	1	80	15	4	10.7
Description		Classification	D ₆₀	D ₃₀	D ₁₀	C _u	C _c
Sand some Silt trace Clay trace Gravel		SM	0.275	0.130	0.025	11.00	2.46

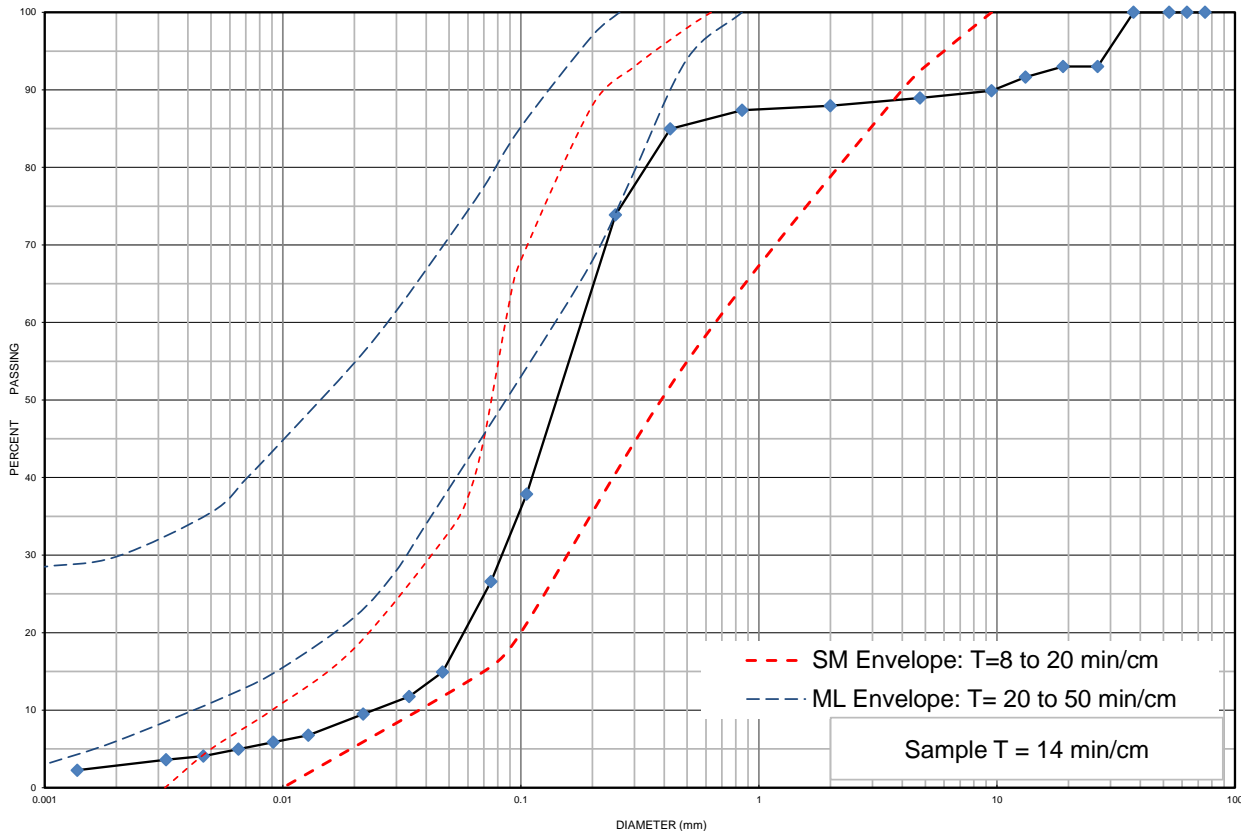
Borehole No.	Sample No.	Depth	Gravel	Sand	Silt	Clay	Moisture
BH 102-21	SS 6	4.6 m to 5 m	11	62	24	3	7.2
Description		Classification	D ₆₀	D ₃₀	D ₁₀	C _u	C _c
Silty Sand some Gravel trace Clay		SM	0.180	0.083	0.025	7.20	1.53

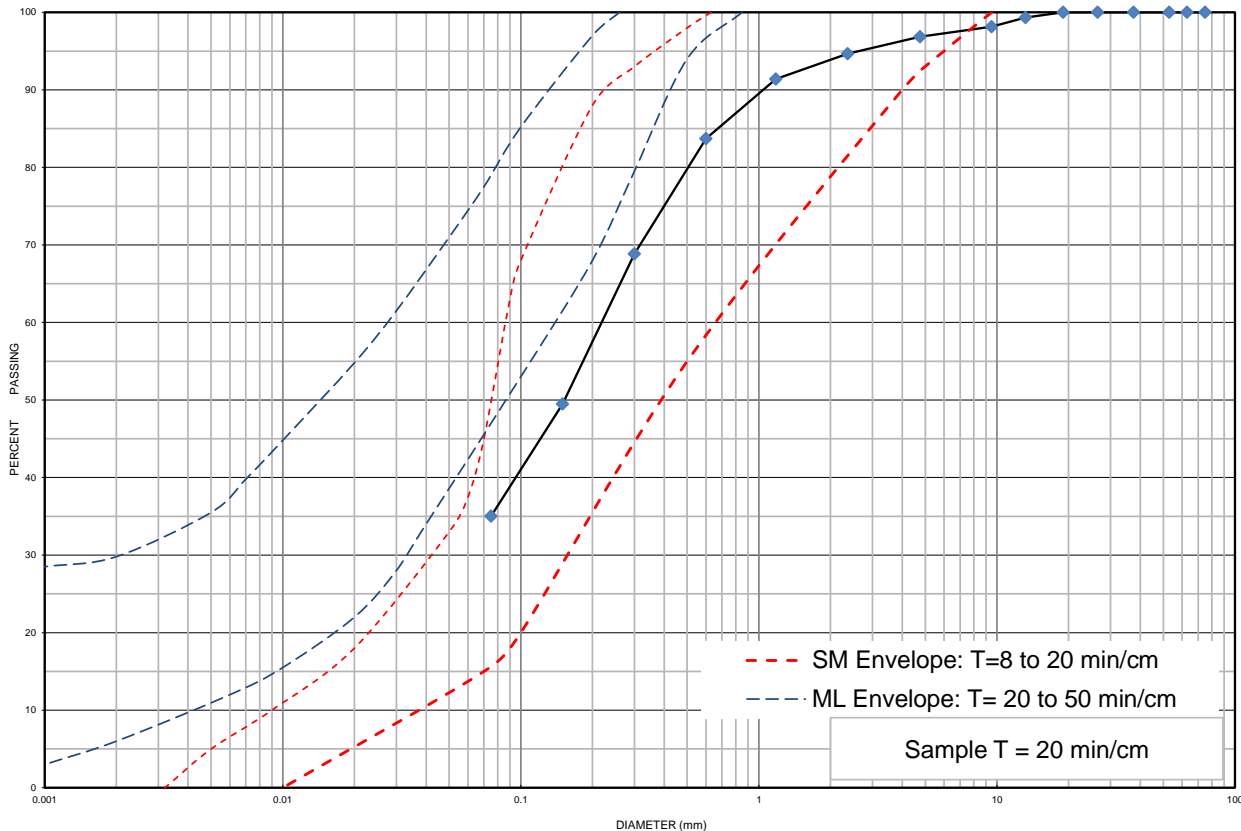
Borehole No.	Sample No.	Depth	Gravel	Sand	Silt	Clay	Moisture
BH 103-21	SS 2	0.6 m to 1.2 m	3	62	35		16.7
Description		Classification	D ₆₀	D ₃₀	D ₁₀	C _u	C _c
Sand and Silt trace Gravel		SM	0.220	-	-	-	-

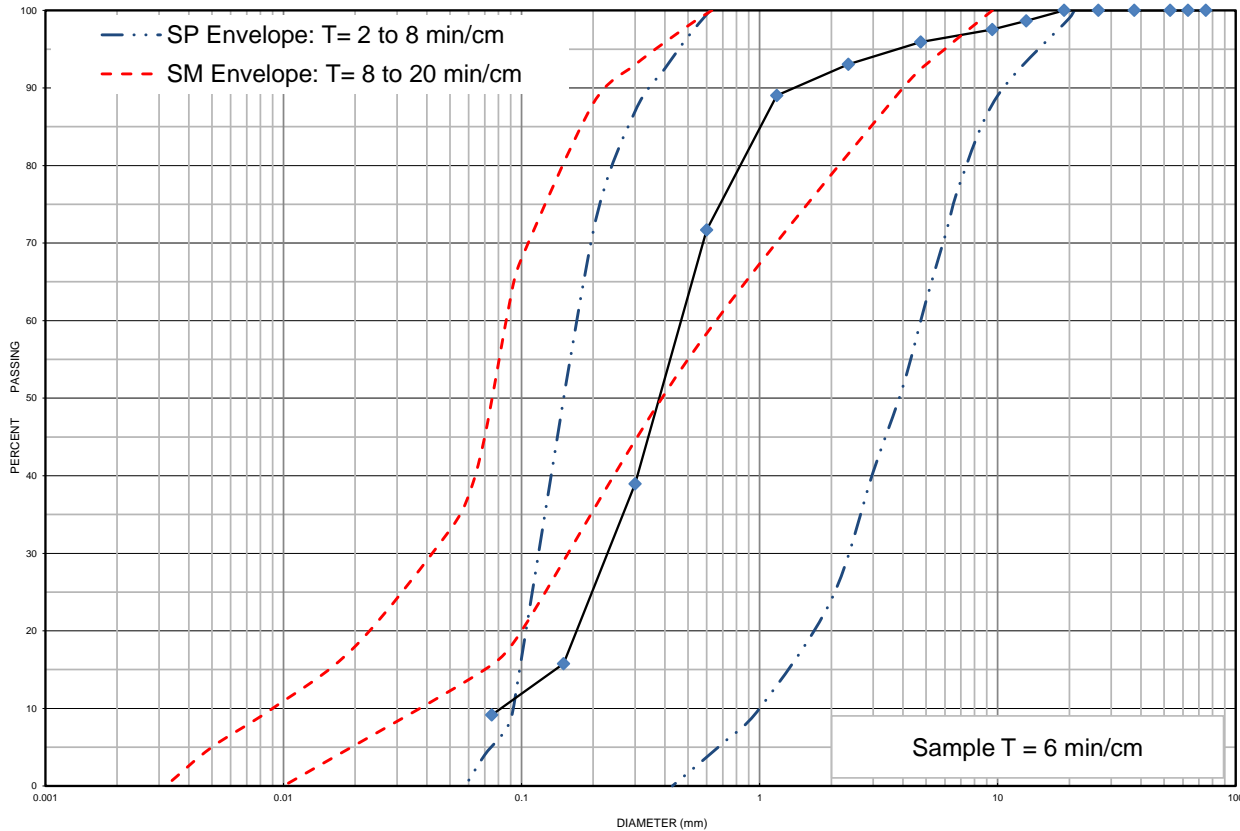
Borehole No.	Sample No.	Depth	Gravel	Sand	Silt	Clay	Moisture
BH 104-21	SS 4	2.3 m to 2.7 m	4	87	9		8.8
Description		Classification	D ₆₀	D ₃₀	D ₁₀	C _u	C _c
Sand trace Silt trace Gravel		SP	0.460	0.135	0.080	5.75	0.50
